**Investigative report on The Small Animals Quarantine in Luqa,  
by The Office of The Commissioner for Animal Welfare  
4th April, 2022**

### **Inspection at Small Animal Quarantine Luqa**

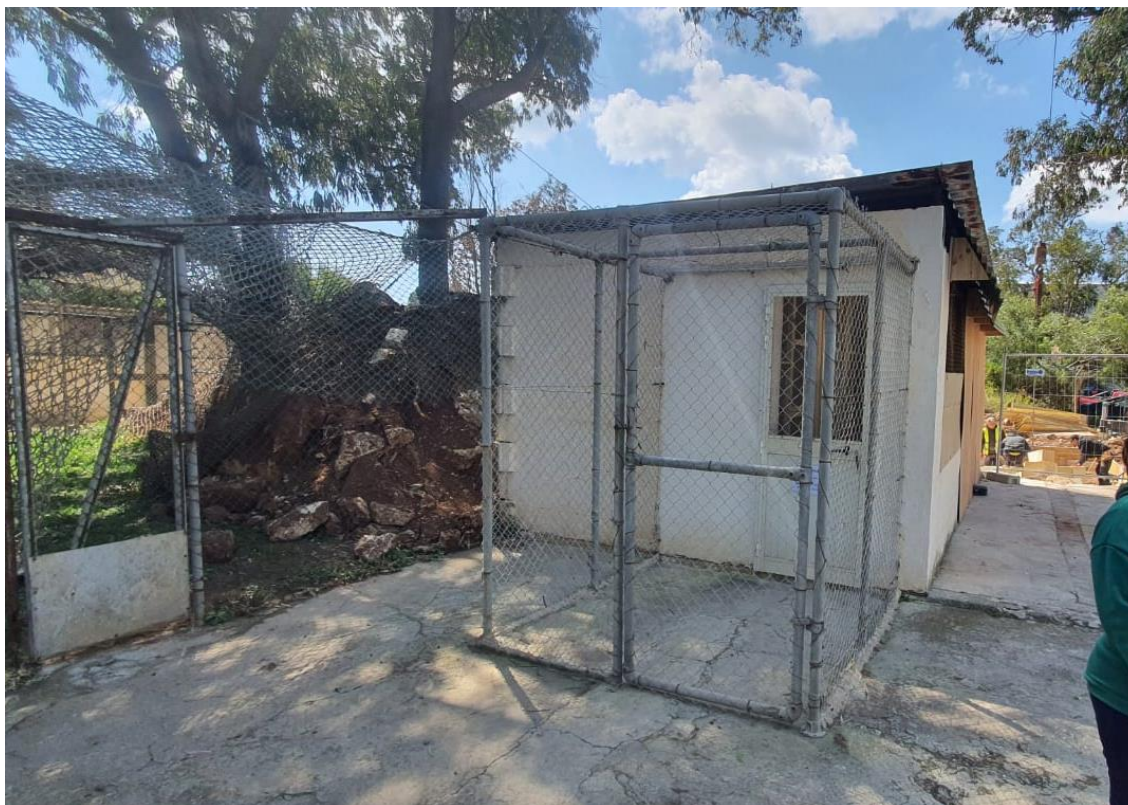
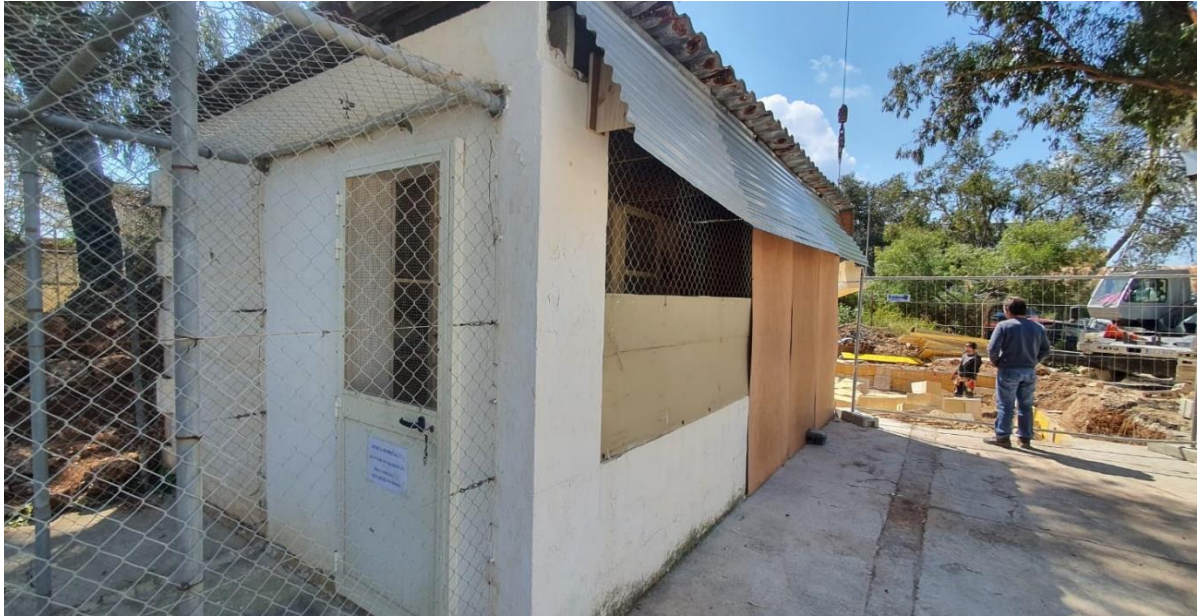
It has been confirmed that all cats currently being kept in quarantine are still being housed in the existing structure that has been in use for the past years. The structure is built with a combination of limestone, metal sheet roofing, and has a façade made up of metal wire for ventilation. It also has an external metal fence ante-room, for additional security to prevent escapees from the unit.

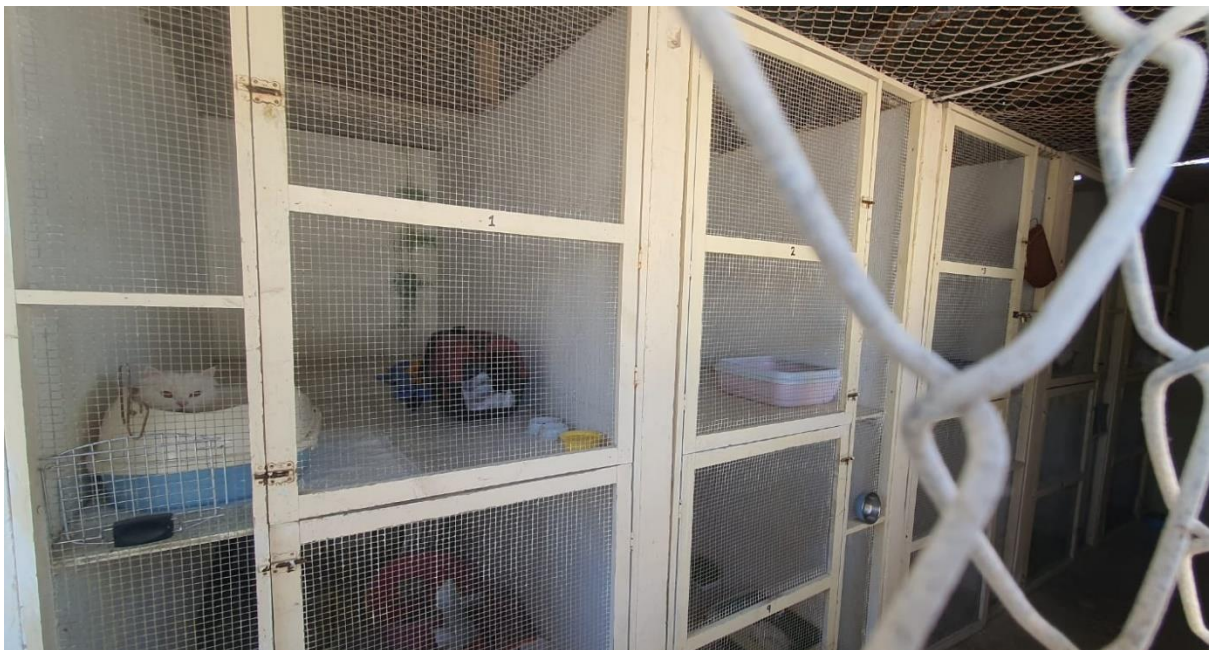
The unit had additional metal sheeting affixed to the façade plus other wooden sheets, mainly to prevent rain and wind to the inside. All these additional temporary materials affixed to the structure continued to make it aesthetically worse than it originally was. It needs to be highlighted that this is a very important factor to be taken in consideration when people have to leave their pet behind in such makeshift structures.

Once the cats are transferred to the new structure, this will definitely provide additional protection from noise and inclement weather conditions. The new modern design, when compared to the existing structure, will also calm the complaints from the public on the unacceptable conditions that one expects to find in an approved quarantine.

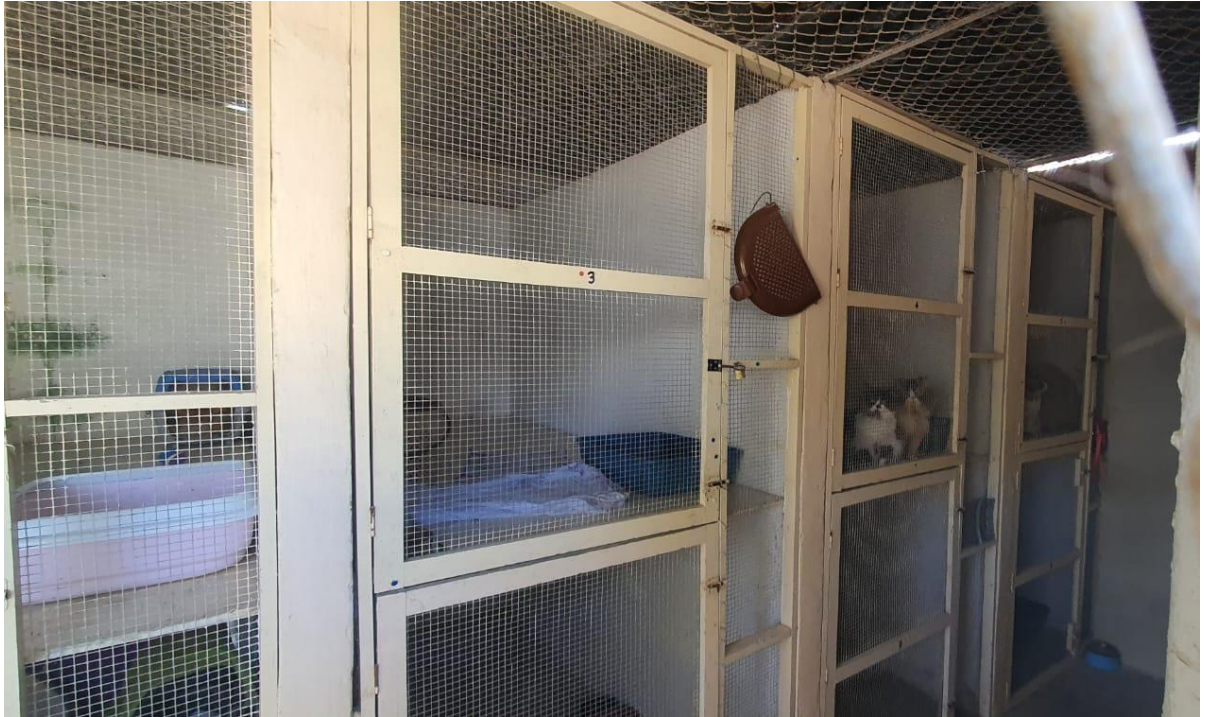
The cats inside were noted to be placed in quite large and spacious enclosures, all of them including bedding and cat litter.

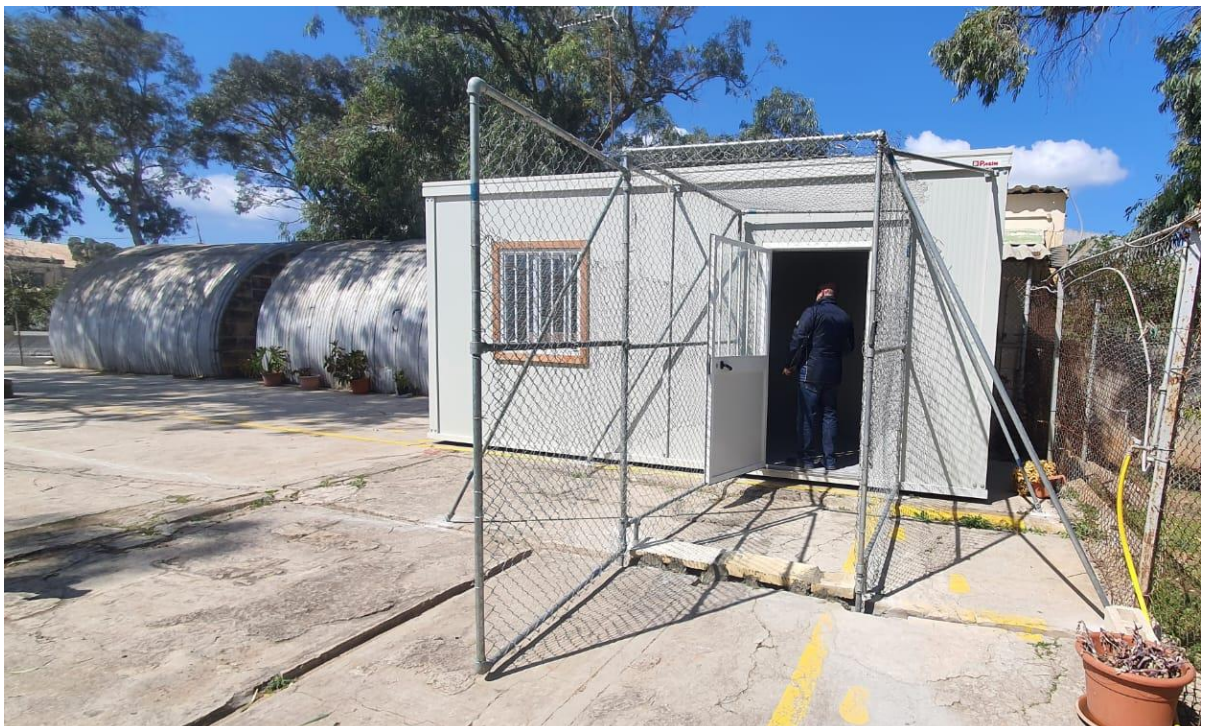
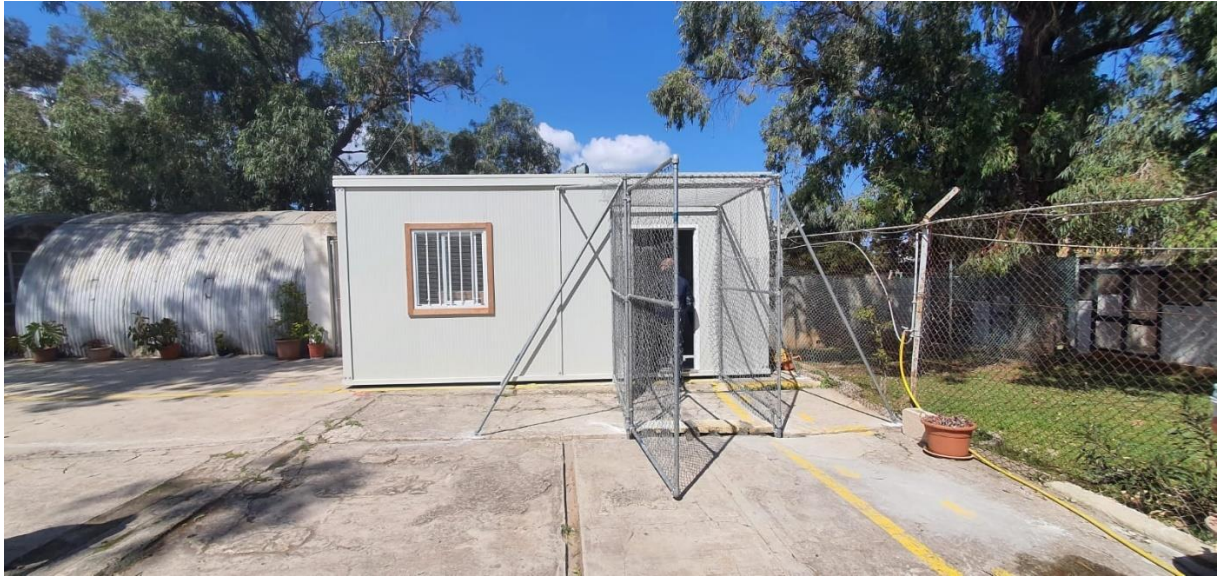
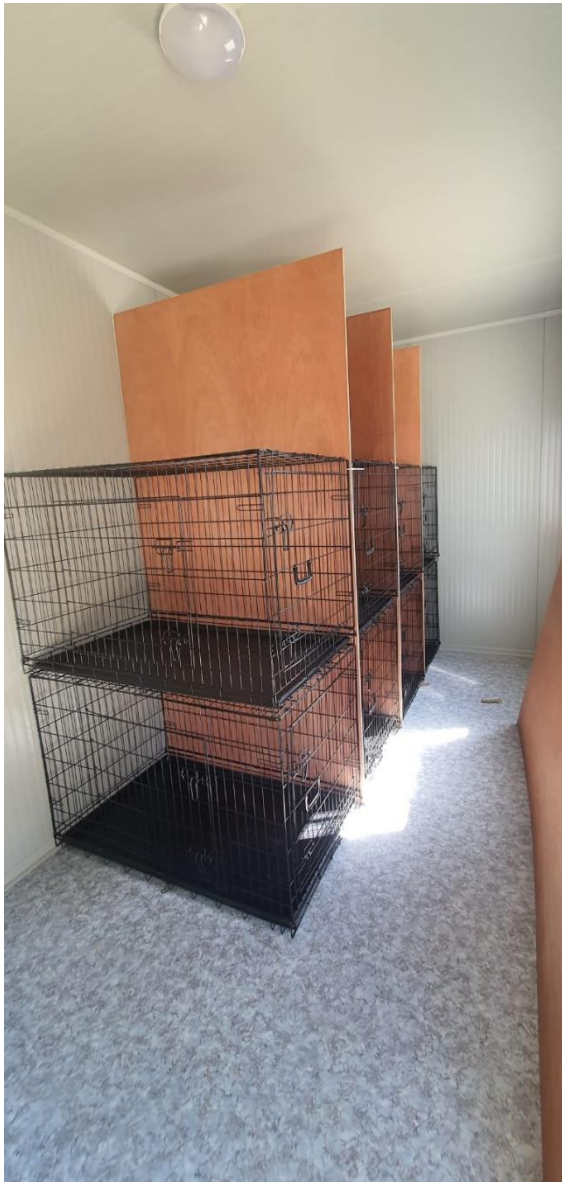
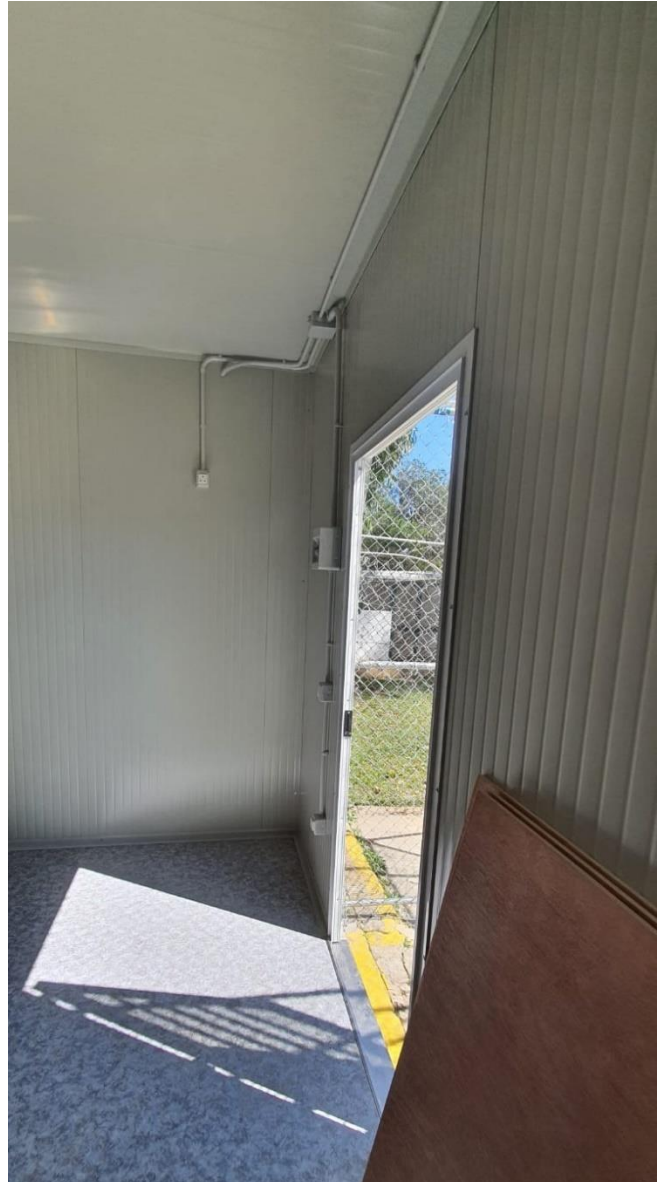
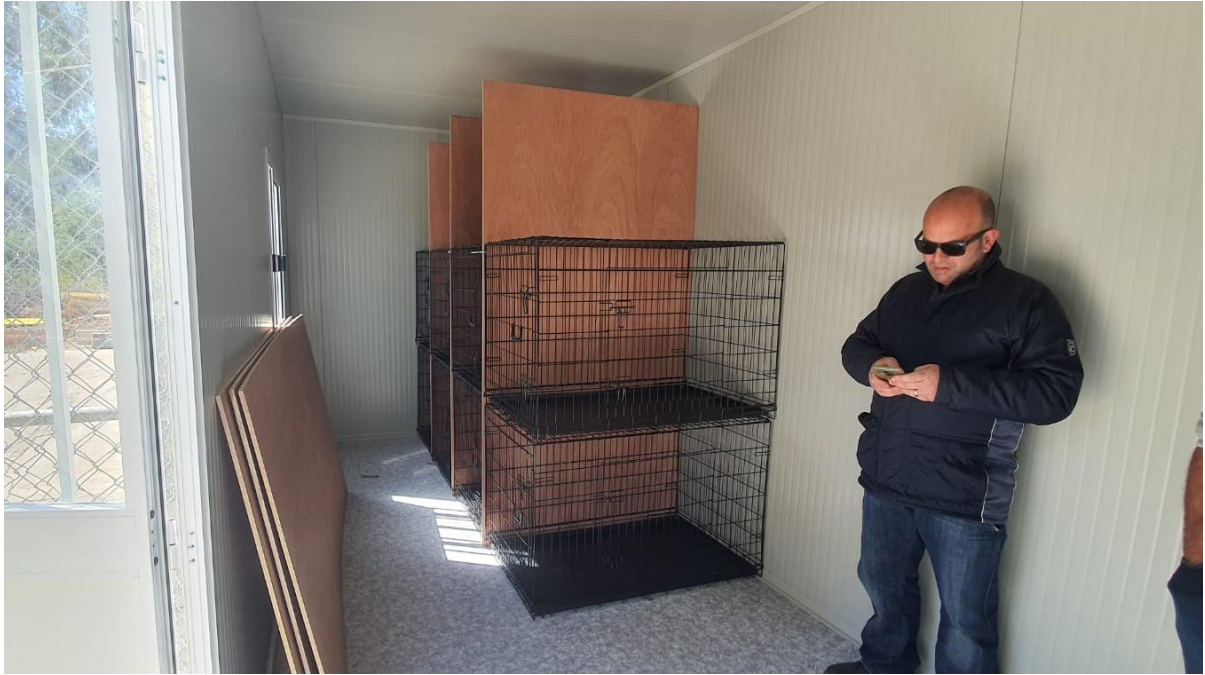
We also noted the newly installed container which will eventually be used to replace this existing structure. The new structure is made up entirely of insulated material, white in colour which reflects heat. It has one door and one window. This new structure was also affixed with a metal fenced ante-room, and this for additional security measures to prevent escapees. The new structure comes with an AC unit as well, which still needs to be installed later today or tomorrow by the contractor. We advised the officers that cats can be transferred inside even without an AC unit in this time of the year. In fact, we were informed that the cats will be transferred in the new unit in these days.

The new structure will be air-conditioned (still to be installed) and will contain 14 individual large enclosures for cats. There are presently 8 large cages placed within, and we were informed that they are waiting for additional 6 cages to be delivered from the supplier.
